SERVICE LETTER 242

Cessna 206H Soloy Hydraulic Pump Replacement Near Firewall on 3450A Floats

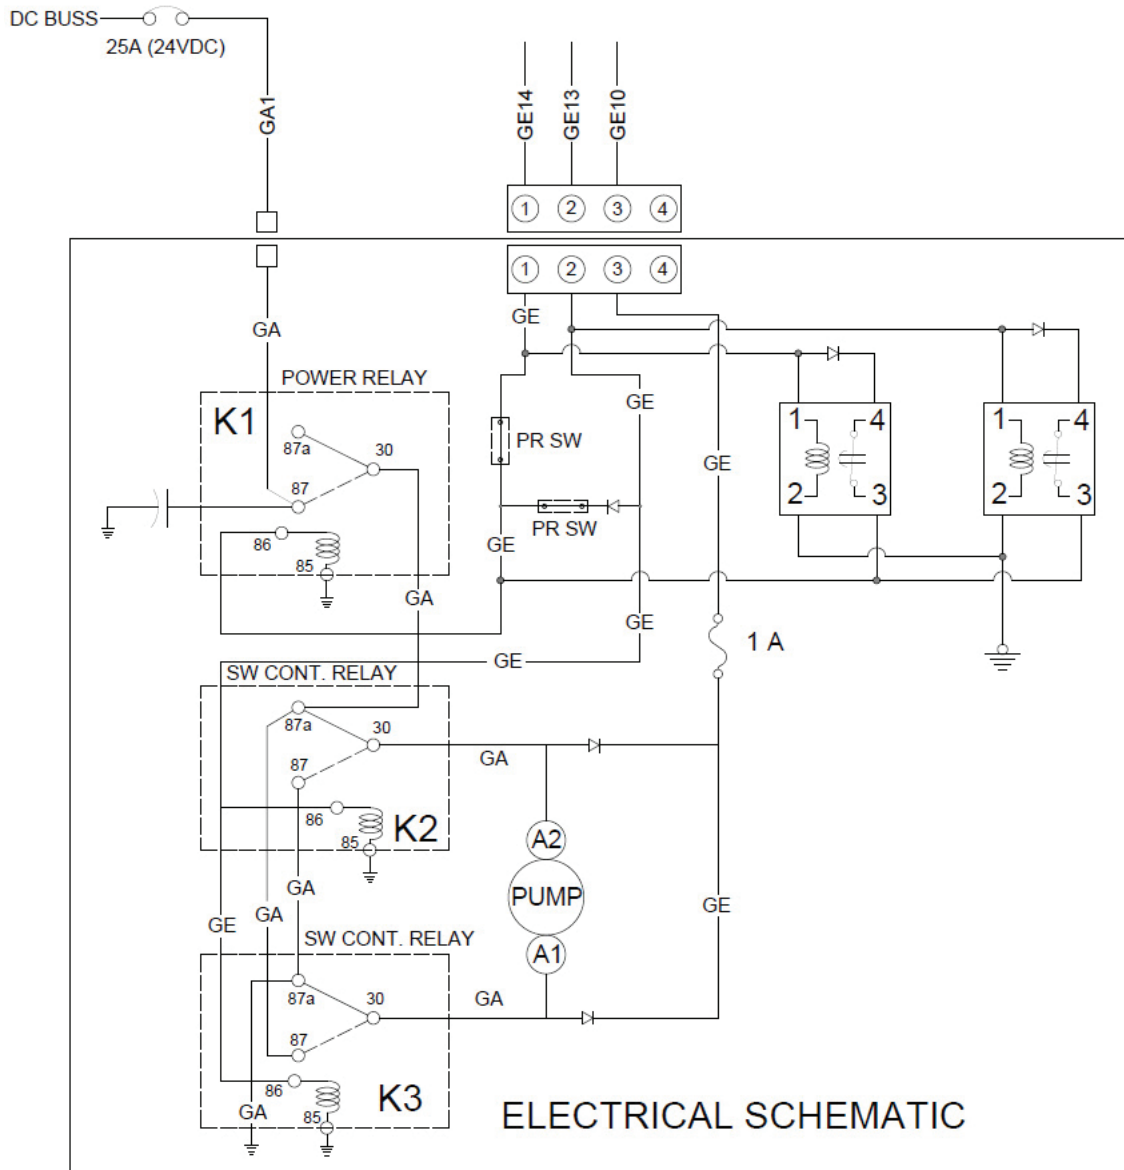
**NEW HYDRAULIC PUMP
1011945**

Textron Aviation (Cessna) 206 Hydraulic Pump Assembly p/n 1009225 has been discontinued. This service letter provides the option to replace it with pump p/n 1011945.

1. Disconnect aircraft battery.
2. Disconnect single pin Molex connector for GA1 wire from hydraulic power pack assembly.
3. Disconnect 4 pin CPC connector from hydraulic power pack assembly.
4. If aircraft has a hydraulic low level warning system, disconnect wire harness from sensor in reservoir.
5. Drain hydraulic fluid from hydraulic power pack reservoir.
6. Remove 1009301 hydraulic line from reservoir fitting to firewall. Note firewall fitting location.
7. Disconnect and cap 1009303 hydraulic line from pump “up” port.
8. Remove 1009302 hydraulic line from pump “dn” port to firewall. Note firewall fitting location.
9. Unbolt and remove hydraulic power pack from firewall and firewall angle.
10. Install new hydraulic power pack onto firewall angle using supplied hardware. Use existing hardware to attach the upper bracket to the firewall.
