SERVICE LETTER 253

Horizontal Stabilizer Spar Cracking At Finlets

Aircraft Makes/Model(s):	Float Model(s):	Compliance: Mandatory	By: MAS
Air Tractor AT-802 & AT-802A	10000A	Part Number: 1012347 Date: 4/5/2023	Approved: DRH Revision: A

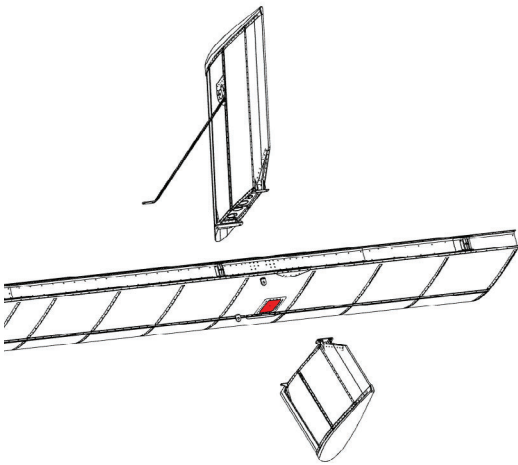
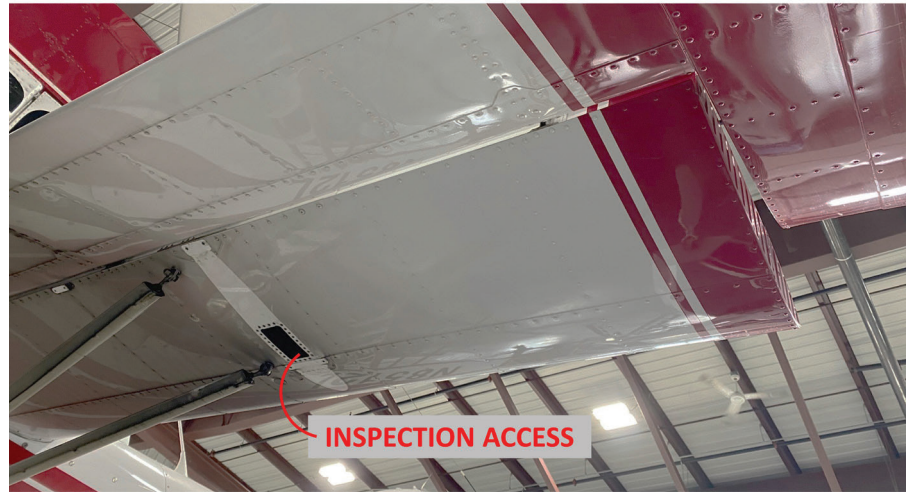
Figure 1
Inspection Access Locations

3. Remove the inspection access cover from the bottom of the right horizontal stabilizer.

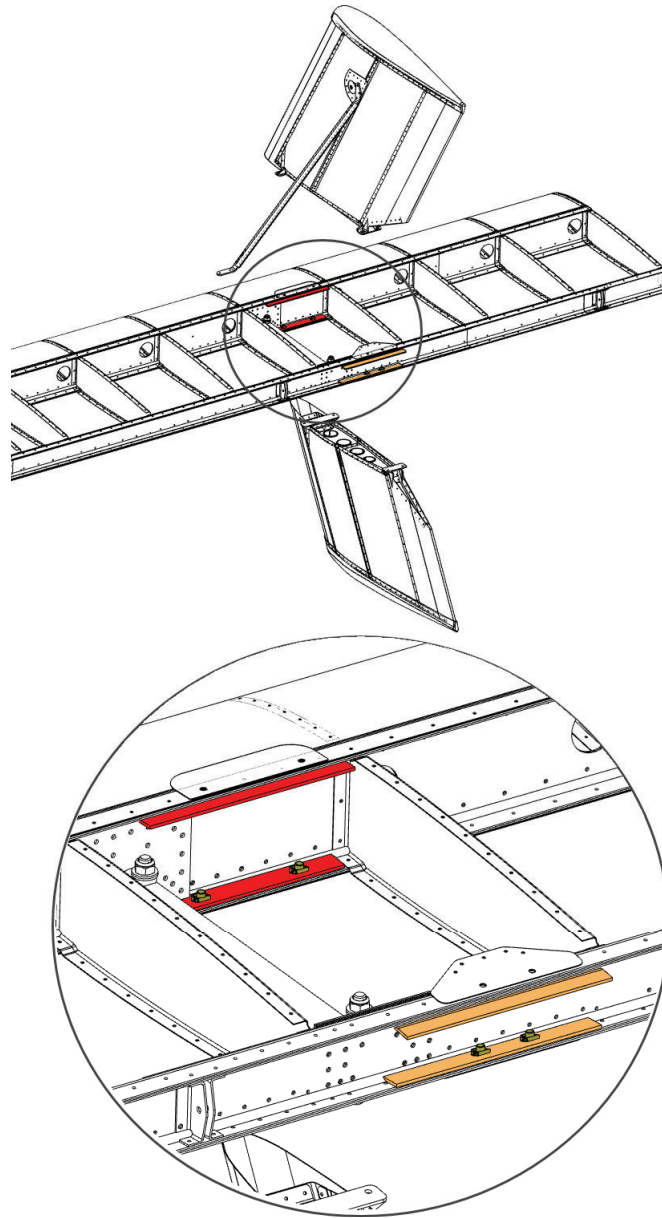
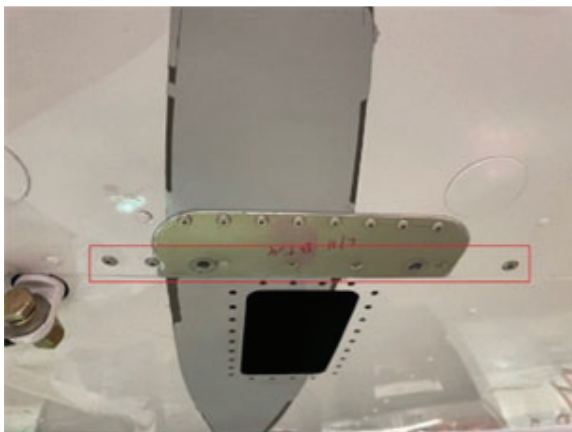
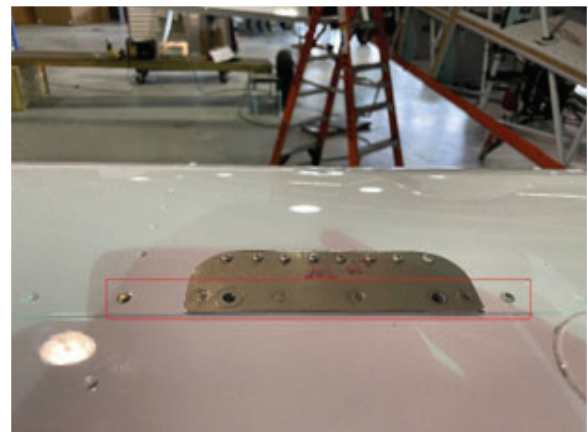
Figure 2
Stabilizer forward spar strap locations (LH stabilizer shown, RH is primary concern)

4. Remove the upper and lower spar strap (10A12001-074) from the forward horizontal stabilizer spar by drilling out the rivets holding it in place. See the parts highlighted in red in Figure 2.
