SERVICE LETTER 253

Horizontal Stabilizer Spar Cracking At Finlets

Aircraft Makes/Model(s):	Float Model(s):	Compliance: Mandatory	By: MAS
Air Tractor AT-802 & AT-802A	10000A	Part Number: 1012347	Approved: DRH
		Date: 3/5/2025	Revision: E

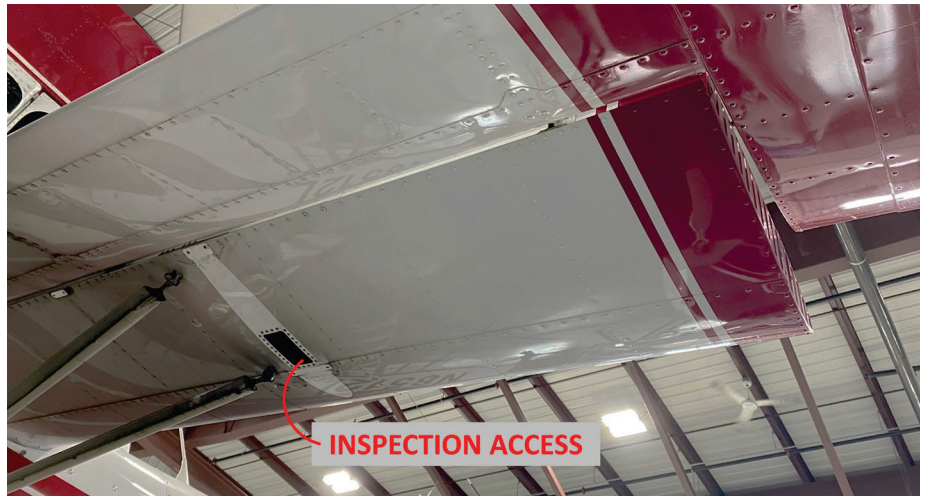
Figure 2

Inspection Access Locations

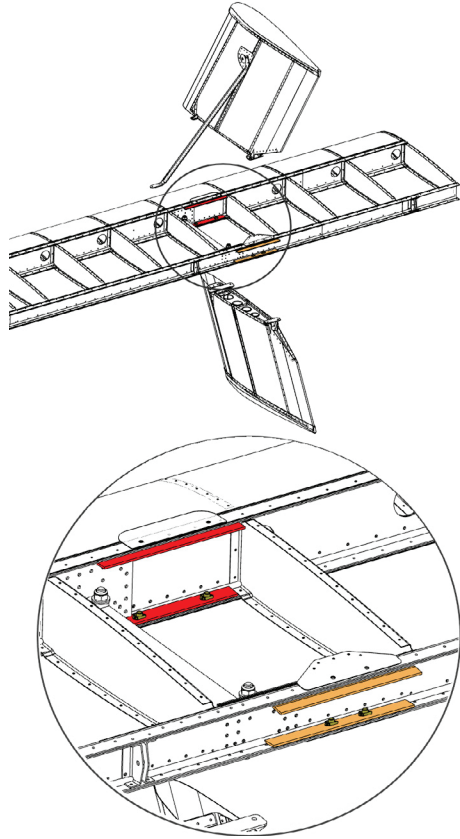
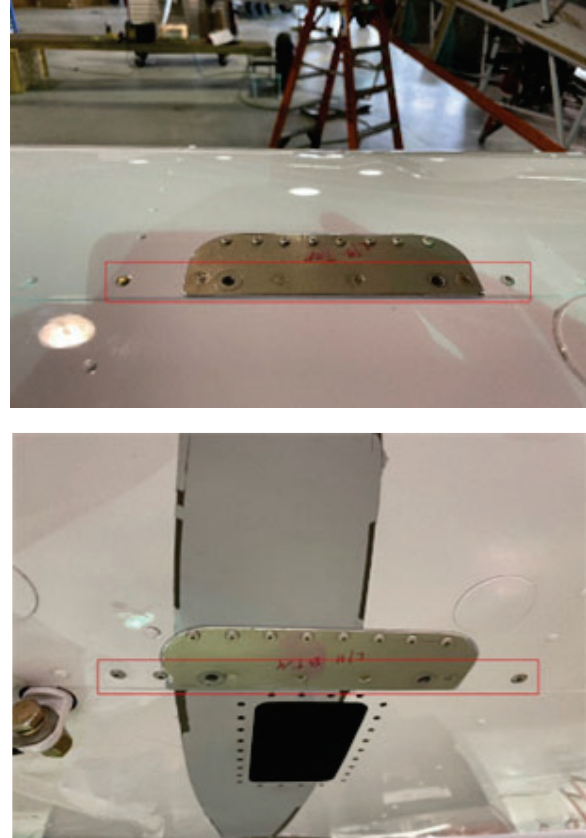
Figure 3

Stabilizer forward spar strap locations (LH stabilizer shown)

4. Remove the upper and lower spar strap (10A12001-074) from the forward horizontal stabilizer spar by drilling out the rivets holding it in place. See the parts highlighted in red in Figure 3.
