WIPLINE FLOATS | MODIFICATIONS | AIRCRAFT SALES  
AVIONICS | INTERIORS | MAINTENANCE | PAINT

## SERVICE LETTER 253

### Horizontal Stabilizer Spar Cracking At Finlets

| Aircraft Makes/Model(s): | Float Model(s): | Compliance: Mandatory | By: MAS |

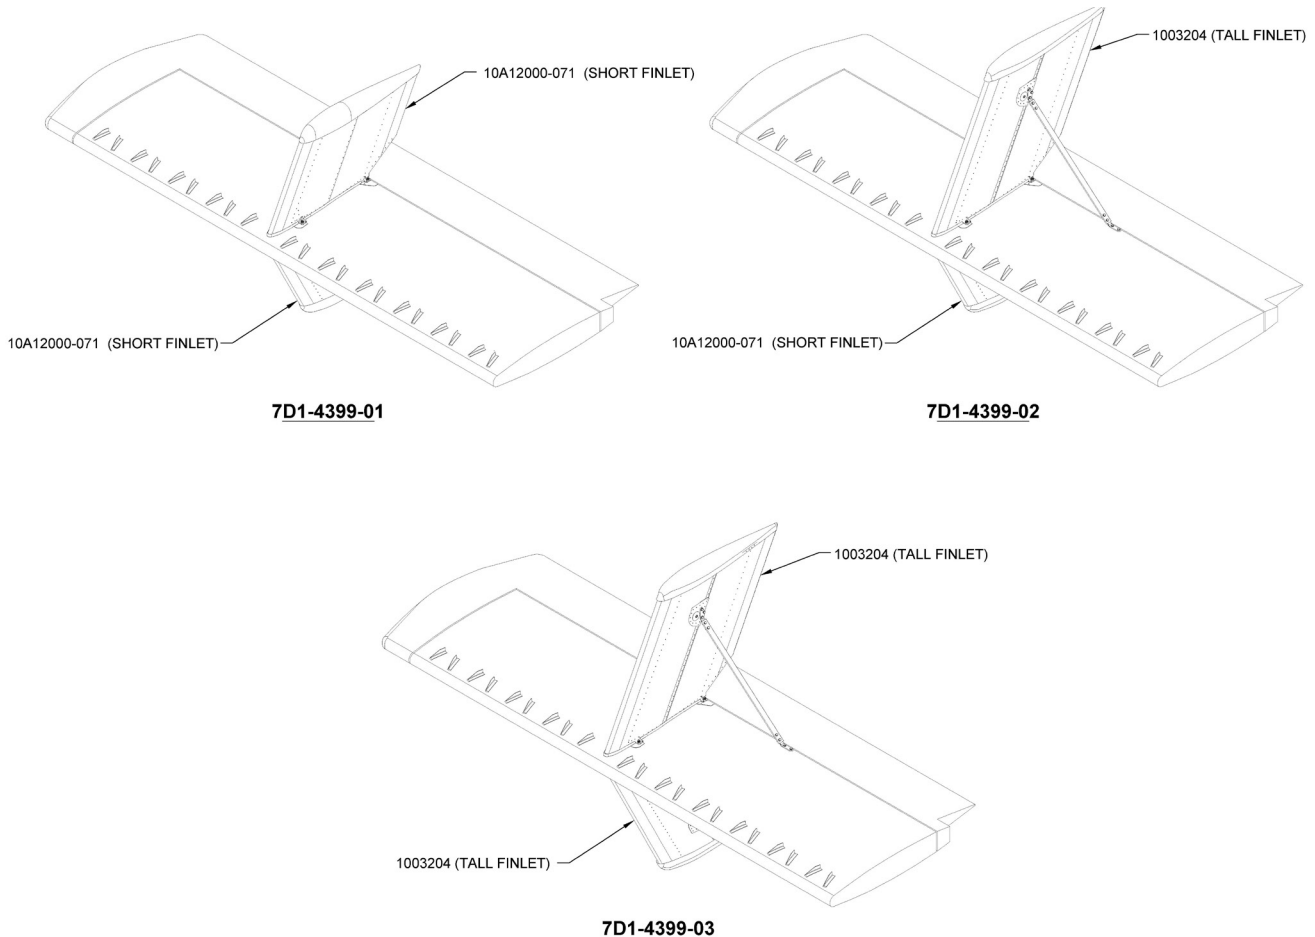
**Figure 1**  
**Finlet Configurations (RH Stabilizer Shown)**

Compliance is mandatory with initial inspection window and recurring inspection intervals based on finlet configuration and spar reinforcement method. Refer to Figure 1 and the tables within the Compliance Method section. Inspection and retrofit procedures are described in the various "work instruction" sections of this service letter.
