SERVICE LETTER NUMBER 158

TITLE: AIR TRACTOR SHORT FINLET INSPECTION AND SUPPORT

This service letter applies to: AT802A with 10A12000-071 Short Finlets (17") installed IAW STC SA01795CH or STC SA01916CH.

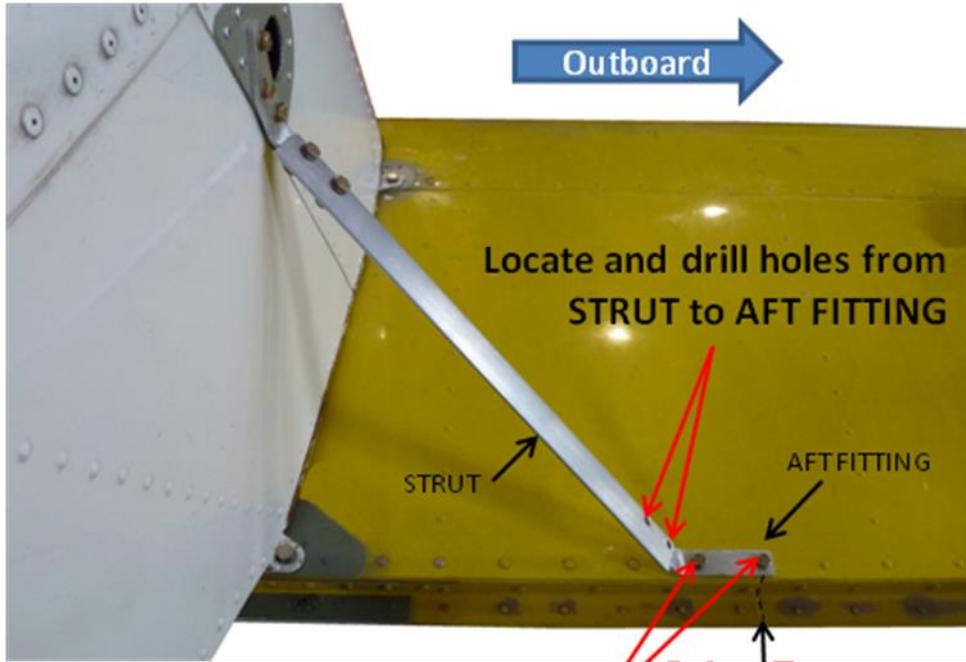
Figure 2: Aft Fitting Location (Upper Right Finlet Shown - Elevator Removed)

Locate common to last two rivets in rear spar doubler

End of rear spar doubler

7. Locate and drill out (2) existing rivets in horizontal tail plane near elevator as shown in Figure 2.
8. Open up the (2) rivet holes in Horizontal Tail Plane to Ø.193"

9. Deburr holes
10. Install the Forward Fitting 1008231/1008232 and loosely attach Strut 1008235. Insert blank end of Aft Fitting 1008233/1008234 into Strut, and attach Aft Fitting to horizontal tail (Figure 2).

9. Deburr holes
10. Install the Forward Fitting 1008237/1008238 and loosely attach Strut 1008236. Insert blank end of Aft Fitting 1008239/1008240 into Strut, and attach Aft Fitting to horizontal tail (Figure 2).
